DUTCH  
SAFETY BOARD

# Near mid-air collision between F-16 and Tecnam

*The Hague, October 2025*

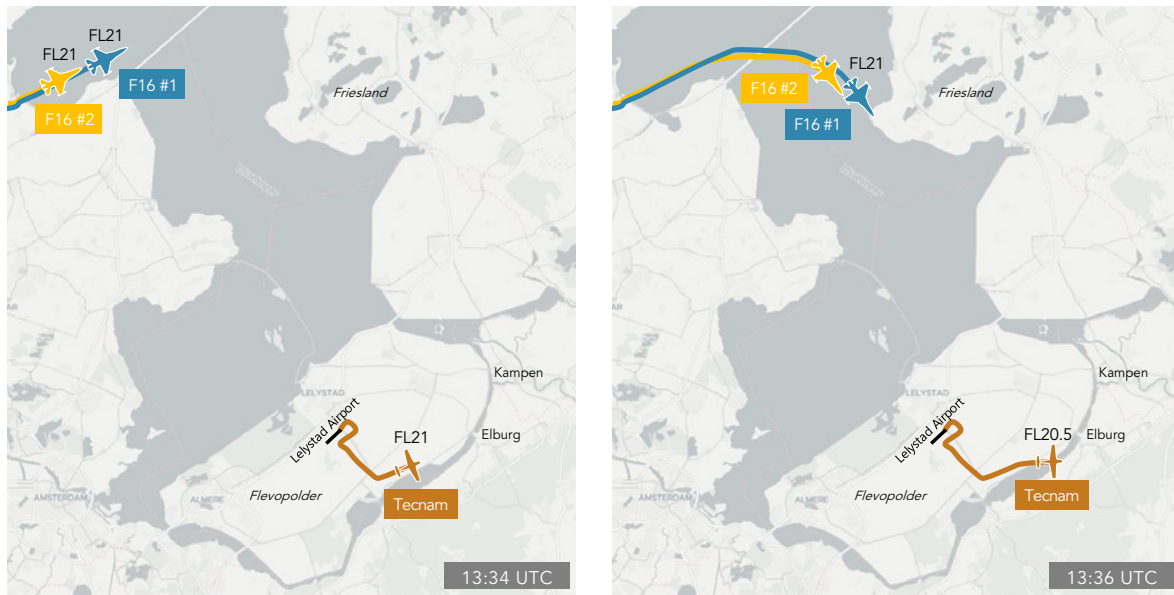
▲ Figure 1: Approximate aircraft positions at 13:34 and 13:36 (source radar data: ATC the Netherlands).

At 13:36, the area controller instructed the formation to climb to 3,000 feet due to VFR traffic flying in the area of Lelystad Airport and opposite IFR traffic. The opposite traffic was another F-16 formation that was scheduled to fly at 2,000 feet along the same route from Volkel to Vlieland. At the time of the area controller's instruction, this formation had not yet departed from Volkel Air Base.

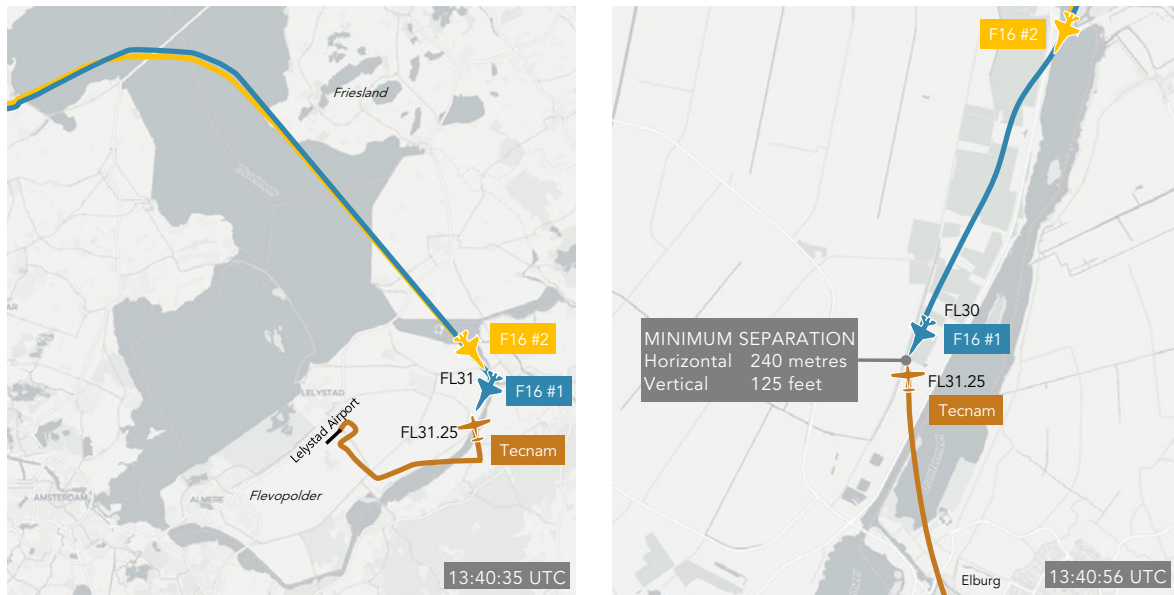
Between 13:36 and 13:40, a colleague relieved the area controller of his duty. At 13:40, near Kampen, the F-16s changed course to a southwesterly direction, see Figure 2. At that time, the new area controller informed the pilots of traffic flying two nautical miles (NM) right in front of Shark 1, at the same altitude. Shark 1 observed an aircraft at 3,000 feet on the AIFF interrogator. This aircraft was however not displayed on his radar screen. Shark 2, flying approximately two miles behind Shark 1, did see this aircraft on his radar screen and informed Shark 1, indicating the aircraft was flying two miles directly ahead and slightly above the horizon. Shark 2 also relayed the aircraft's radar track to Shark 1 via datalink.

The pilot of Shark 1, considering the F-16's high speed, decided to focus on visually identifying the traffic. Shortly thereafter, Shark 1 spotted three lights and identified a white propeller aircraft with a tricycle landing gear at close distance. The pilot immediately performed an evasive manoeuvre by making a sharp descending turn to the right.

ATC radar data indicated that Shark 1 and the Tecnam passed each other with a minimum horizontal separation of approximately 240 metres and a vertical separation of 125 feet. The groundspeed of Shark 1 at the time of the manoeuvre was approximately 420 knots.

▲ Figure 2: Aircraft positions at 13:40:35 (course change near Kampen) and 13:40:56 (near miss) (source radar data: ATC the Netherlands).

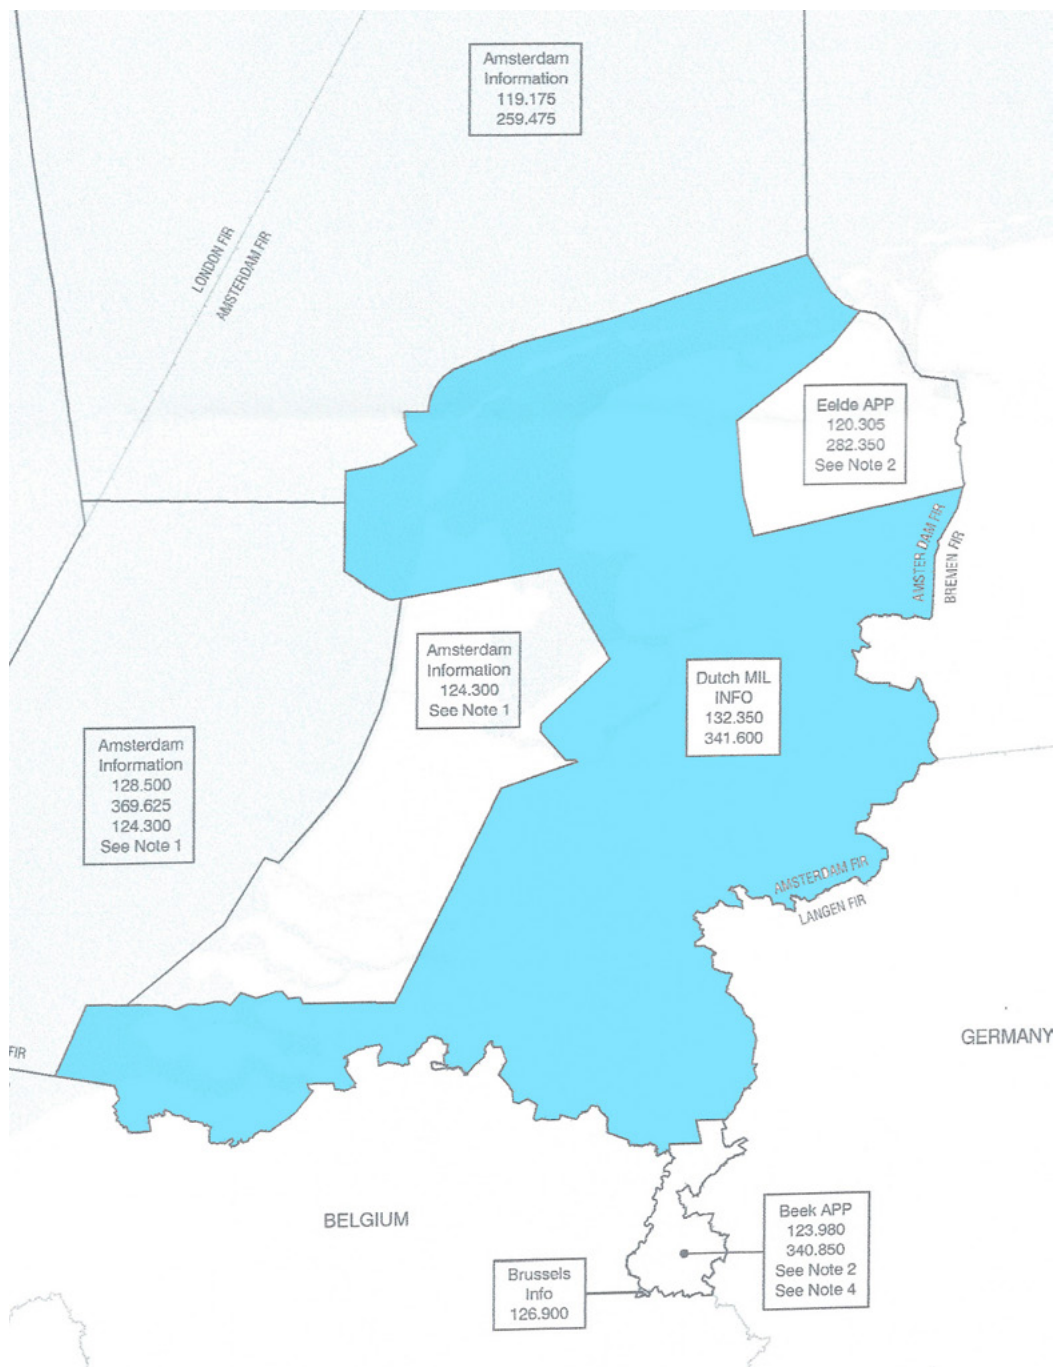
The FISO did not notice a potential conflict between the Shark formation and the Tecnam and did not see the near miss. He only learned of the incident from the area controller. The FISO stated that he could not explain why he had missed the event, suggesting that, given the large work area he was monitoring (see Figure 3), his attention might have been focused elsewhere, despite his low workload.

▲ Figure 3: Airspace under responsibility of the Dutch Mil FISO (blue) (source: AIP the Netherlands – blue area highlighted).

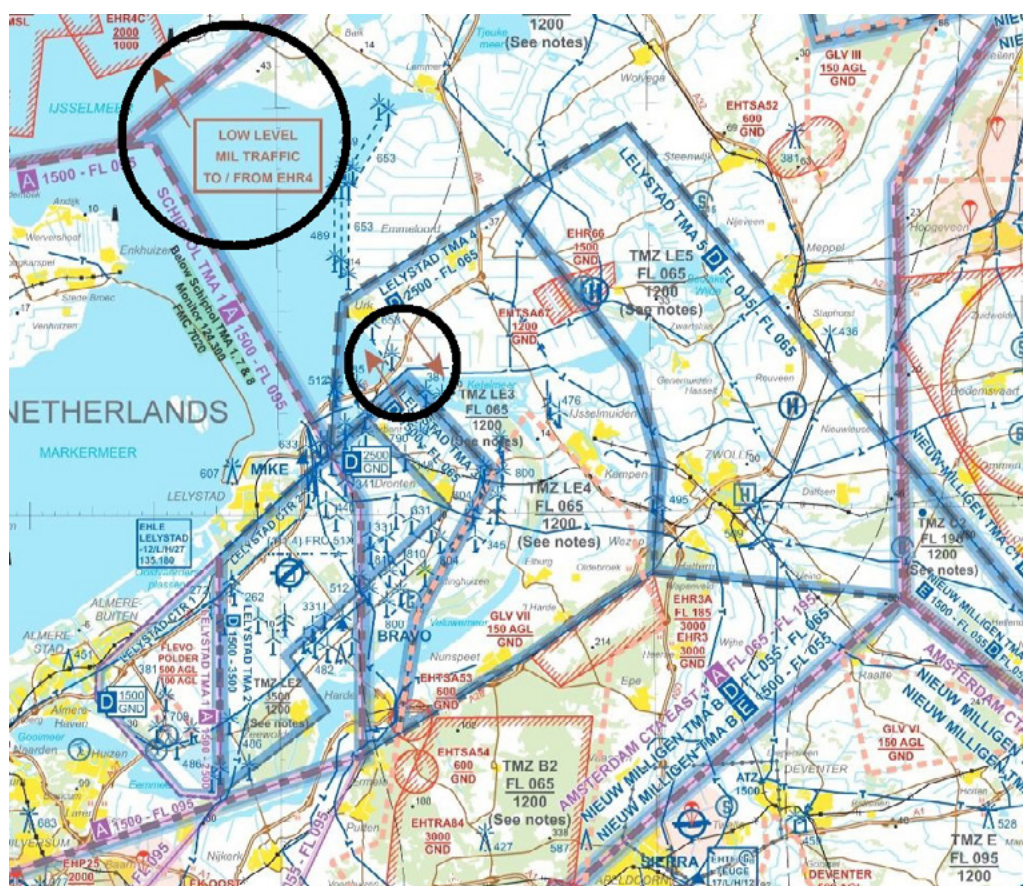
The incident occurred near Elburg at around 3,000 feet. At this location, the airspace from 2,500 feet to FL065<sup>17</sup> is called 'Lelystad Terminal Control Area 4' (Lelystad TMA 4). The responsible service provider is MilATCC Schiphol. The airspace classification for the Lelystad TMA 4 depends on the time of day. According to the AIP of the Netherlands and published charts, this airspace is classified as class D. However, in AIP Supplement 03/2022<sup>18</sup> it has been determined that from 1 April 2020, this area is classified as class E between 21:00 and 17:00 the next day.

▲ Figure 6: Part of the aeronautical chart with the 'Low level Mil Traffic' warnings highlighted (source: Aeronautical Chart The Netherlands, Edition 2024, LVNL - warnings highlighted).

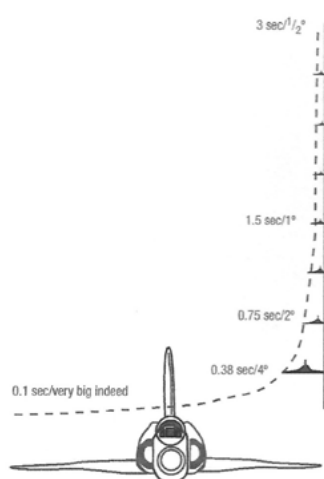
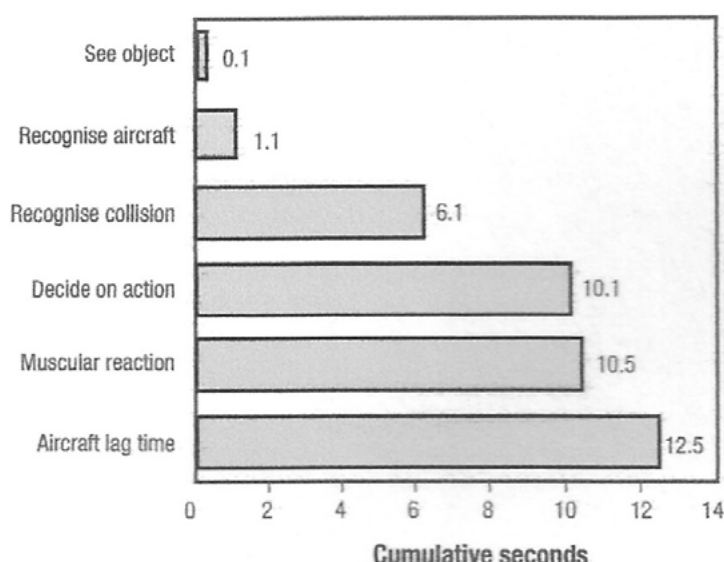
The limitations of the see and avoid principle become even more apparent at higher closing speeds, such as in the case of high-speed military fighter aircraft. Research on this subject shows that, given the speed of a military fighter aircraft, it may only take some seconds before a head-on approaching fighter aircraft becomes visible. In general, when a pilot notices the other aircraft, it takes around ten seconds before he decides on action and initiates an evasive manoeuvre. The same is true for the pilot of the high-speed fighter aircraft. Given the speed at which both aircraft are approaching, the military pilot too will have little time to detect a small aircraft and take evasive action.

▲ Figure 7: Visibility of a military fighter aircraft related to time and reaction time for an evasive manoeuvre (source: Australian Transport Safety Bureau (ATSB), *Limitations of the See-and-Avoid Principle*, 1991, reprinted 2004).
