**REPORT**  
**OF THE**  
**OPERATIONAL SAFETY REVIEW TEAM**  
**(OSART)**  
**MISSION**  
**TO THE**  
**BORSSELE**  
**NUCLEAR POWER PLANT**  
**THE NETHERLANDS**  
**23 JANUARY – 9 FEBRUARY 2023**  
**AND**  
**FOLLOW-UP MISSION**  
**19 – 23 MAY 2025**

**DIVISION OF NUCLEAR INSTALLATION SAFETY**  
**OPERATIONAL SAFETY REVIEW MISSION**  
**IAEA-NSNI/OSART/216F/2025**

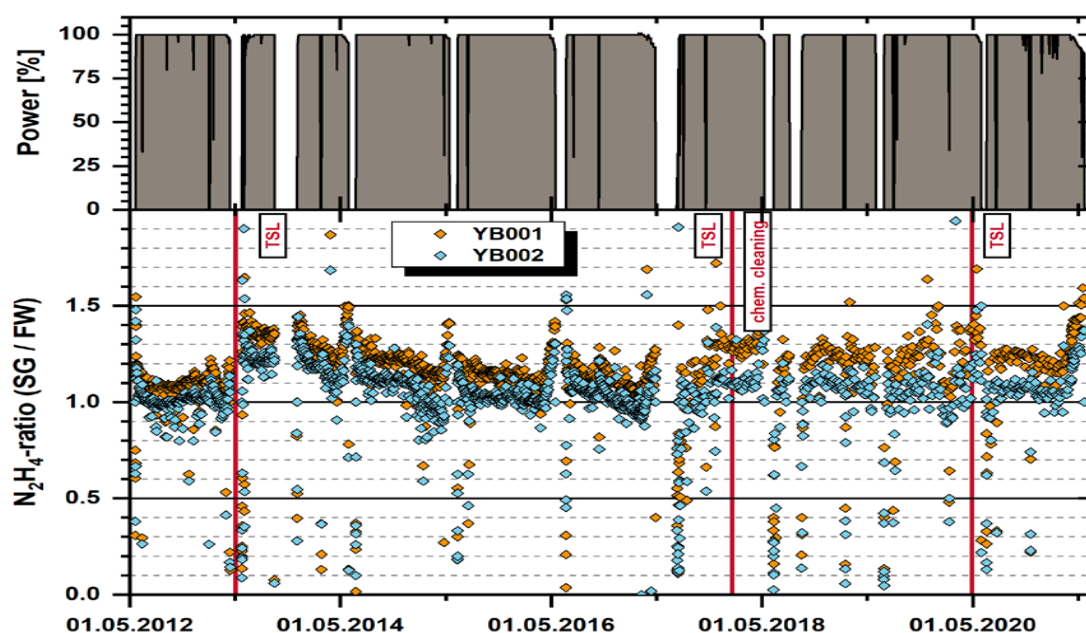
- An increase of hydrazine ratio in the operating cycle after the mechanical tube sheet lancing in April 2013 (indication of a significant decrease of corrosion products in steam generators).
- An increase of hydrazine ratio after the chemical-mechanical tube sheet cleaning in May 2017.
- An increase of the hydrazine ratio after the mechanical tube sheet cleaning in June 2019 and April 2022 inspection.

Long-term monitoring of hydrazine ratio
