# Report on the fieldwork at the sites of the Dutch submarines O16 and K-XVII

*M. Manders, R. de Hoop, M.H.W. Verrijth, C.H. Trommel, H. Meinsma, I. Jeffery, T.A. van der Velden, Ruzairy Bin Arbi, Farizah Binti Ideris, Ahmad Zaharuddin Bin Abdul Kadir, Khairil Amri, Bin Abdul, Ghani*

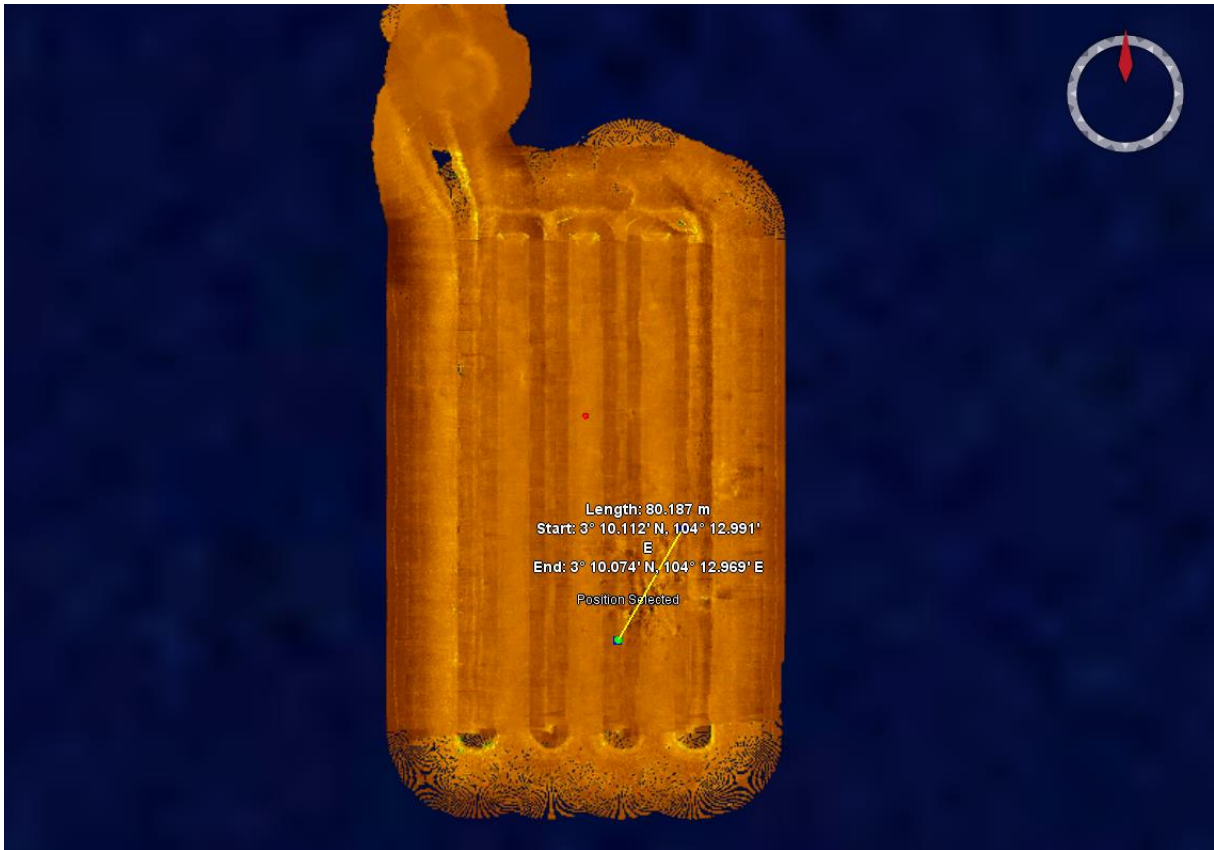
Figure 3: Side scan sonar mosaic made with the Remus at the O16 wreck site.

After that a more close range mapping of the located objects on the seabed was executed. This resulted in the conclusion that indeed the middle part of the ship is completely gone. An impression that resulted from the salvage operation is still visible on the seabed. The areas of the bow and stern have been heavily damaged and are almost gone as well. Fragments and lower parts of the cylinder body can be spotted on the side scan sonar.

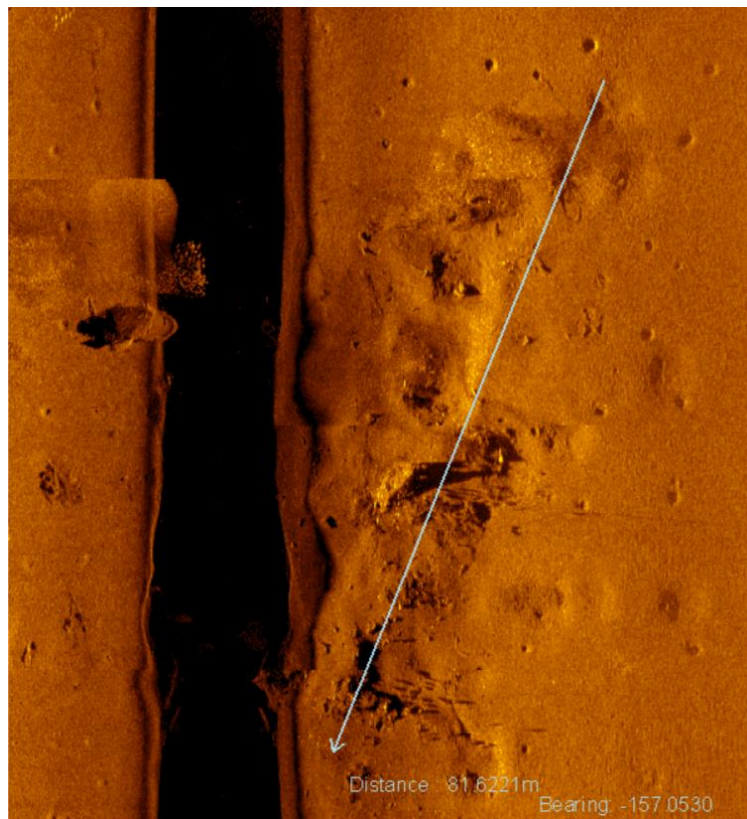
Figure 4: Detail of the wreck of the O16. Only small fragments of the wreck still exist onsite.

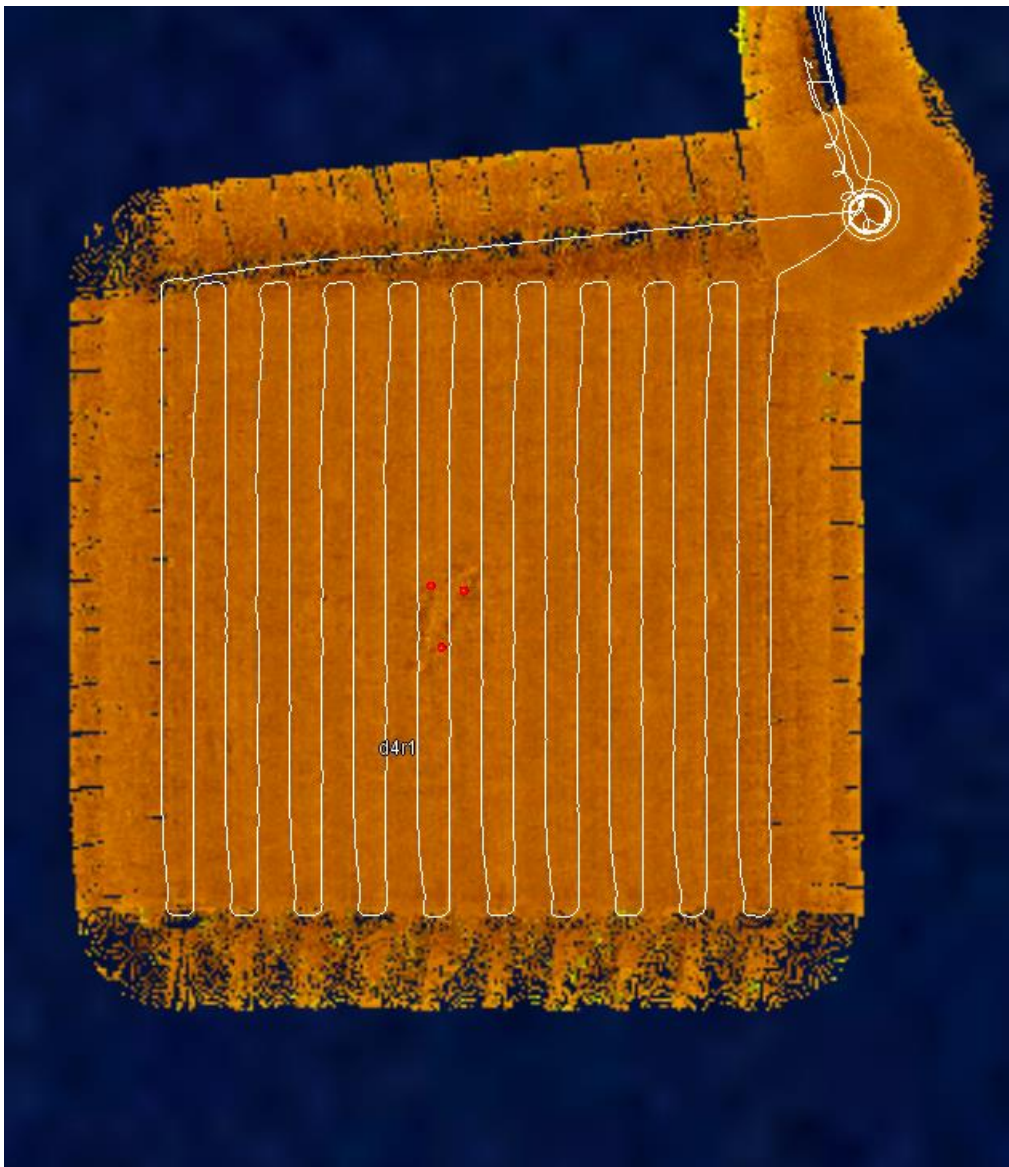
Figure 5: Side scan sonar mosaic of the K-XVII wreck site made with the Remus sonar.

The last information the team has had from a diver was that he dived the site on the 18<sup>th</sup> of May 2018. At that time, according to his report, at least large parts of the wreck were still visible on the site. When surveying the site with the REMUS it became immediately clear that the site was now almost completely salvaged. In a 'box' of 500 by 500 m, there is a small seabed area of approximately 90 metres of length that has been disturbed.

Traces of salvaging are visible, including anchor dragging. Here and there, small pieces of deformed wreck material were detected, not more than a few metres long. The image was clear enough to conclude that the wreck has been salvaged. Due to the fact that the imagery was already at its best, it was decided by the team that there was nothing to gain with further research.

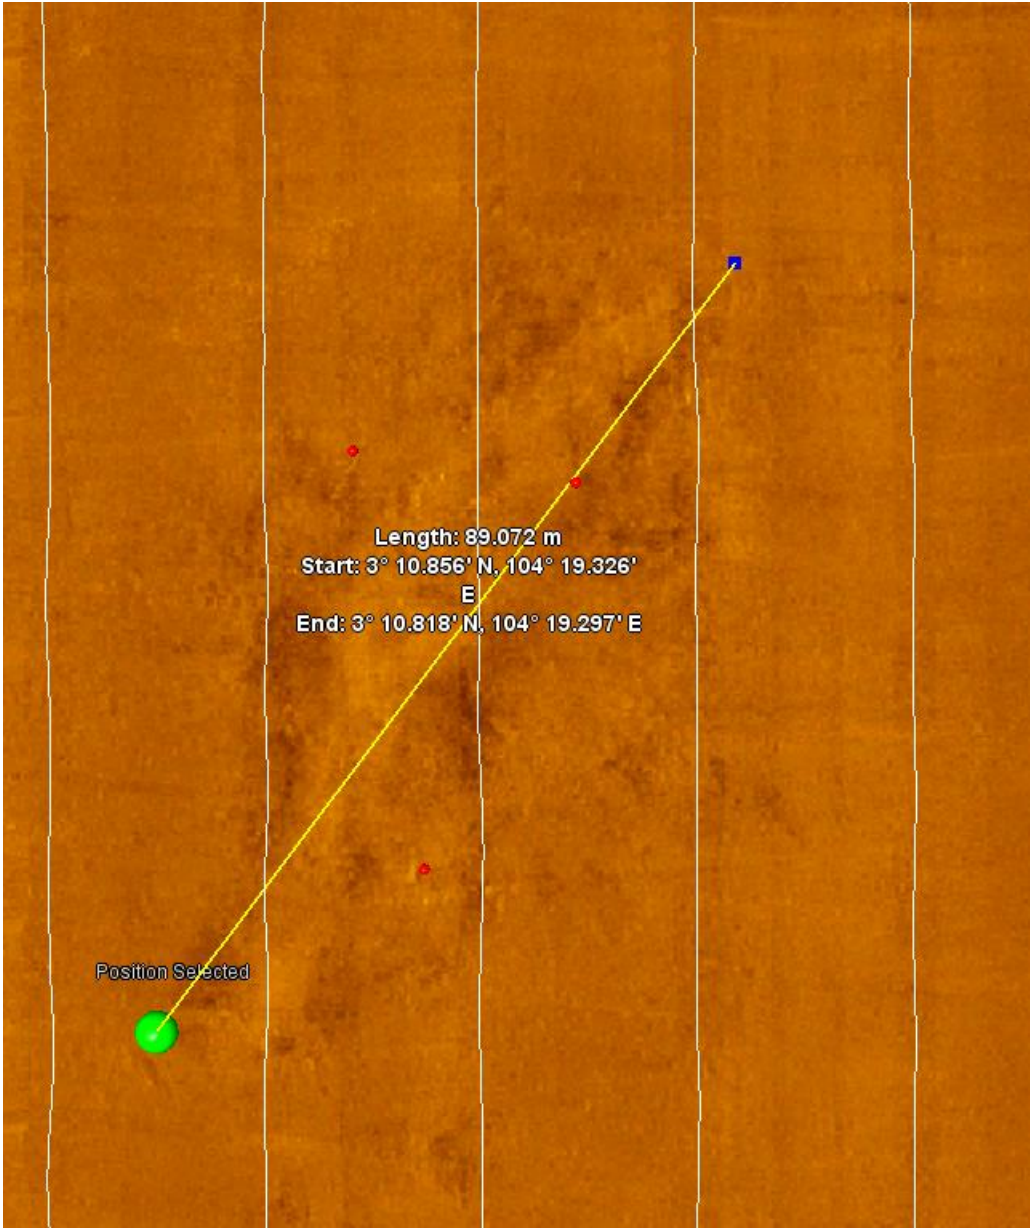
Figure 6: Sonar detail of the K-XVII wreck site. Hardly any wreck material is left onsite.
