**MV “FREMANTLE HIGHWAY”  
IMO 9667344  
FIRE ON BOARD  
Casualty Date: July 25<sup>th</sup> 2023  
Casualty Place: Northsea – The Netherlands EEZ  
VERY SERIOUS MARINE CASUALTY  
REPORT NUMBER: R-016-2024-DIAM**

**SAFETY INVESTIGATION REPORT**

**FIRE ON BOARD M/V FREMANTLE HIGHWAY**

**On July 25<sup>th</sup>, 2023**

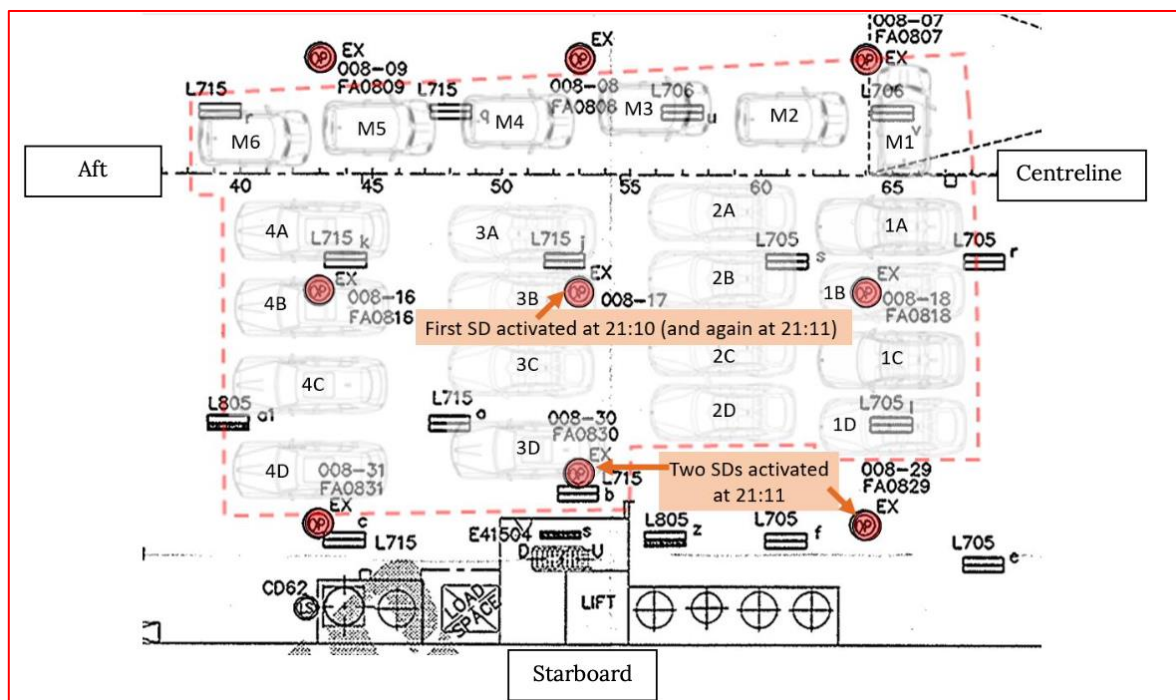
**FIGURE 5: ARRANGEMENT OF SMOKE DETECTORS AND VEHICLES ON DECK 8**  
 (Source: MTD fire experts report)

The below figure illustrates the arrangement of the smoke detectors (highlighted red) in the area of concern on Deck 8 (red dashed line). The three SDs that were activated are denoted. The vehicles are also arranged. BMW iX1s comprise vehicles 1A and 1C. Vehicles 1B, 1D, 2A, 2B, 2C, 2D, 3A, 3B, and 3C were all BMW i7s; all BMWs were electric vehicles (EVs). The Minis M1-M6 were stowed to the port of the centerline. 3D, 4A, 4B, 4C, and 4D were Rolls Royce vehicles.

The first alarm (SD 008-17) activated at **23:10hrs LT**. This detector is central to the area of interest and suggests a fire originating close to vehicle 3B.

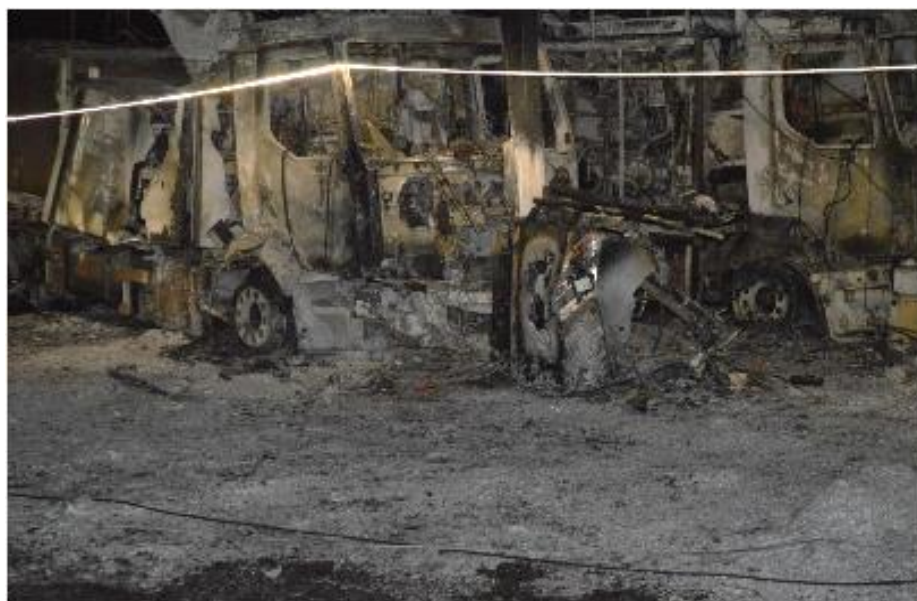
**FIGURE 6: TRUCKS EQUIPPED WITH AN AERIAL PLATFORM ON THE  
5<sup>TH</sup> DECK**

Due to the harmful substances on board, the investigation on board was conducted on a limited basis, under supervision and with the proper personal protective equipment. On the starboard side, the “fire experts’ team” entered the vessel at the pilot entrance on the **5DK**. At the level of the bow, the flexible **6DK** was placed in the highest position. On **5DK** were mobile cranes, transfer cranes and trucks, equipped with an aerial platform stored. Parts of the floor of the **5DK** were covered with solidified aluminum, which had flowed through holes in the decks above.

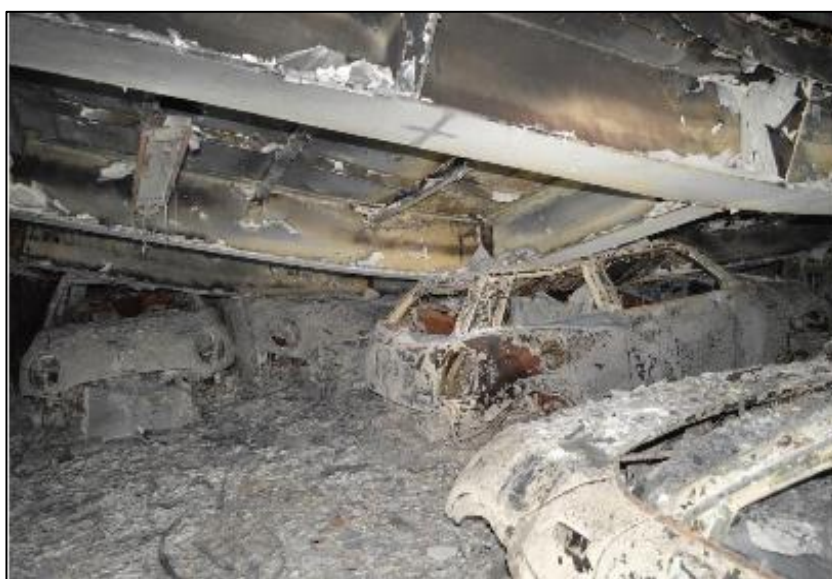
**FIGURE 7: CRUSHED VEHICLES AT 7<sup>TH</sup> DECK**  
(Source: Physical inspection O/B - Fire Expert Report)

Through the stairwell in the bow of the vessel, the “fire experts’ team” went to the mooring deck on the **7DK**. On the mooring deck lays an EEBD (Emergency Escape Breathing Device). From the previously received statements and interviews with the crew members, the “fire experts’ team” concluded that the EEBD was left by the third officer before he jumped in the sea/water. The life rafts on the mooring deck were still in place at the embarkation stations. Inside at the **7DK**, seen from the bow, the total destruction of the stowed cars was visible, **8DK deck** came down partially and crushed several vehicles underneath.

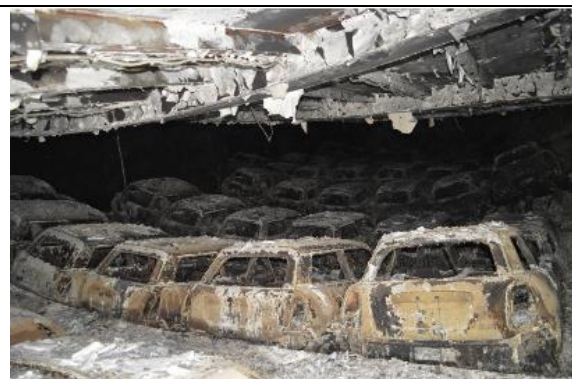
**FIGURE 8: 8<sup>TH</sup> DECK PORT SIDE**  
(Source: Physical inspection O/B - Fire  
Expert Report)

The vehicles on the port side of **8DK** were still identifiable as vehicles. The vehicles on the starboard side are barely recognizable as vehicles; the destruction was enormous, and therefore, it can be considered as the area where the fire started. It was not possible for the “fire experts’ team” to go between the remains of the vehicles. Sections of **8DK** were deformed and other sections had fallen down in their entirety. Traces found on sections of **8DK** such as parts that had fallen from cars, show that the collapse of certain sections of this deck was a result of the fire which developed at a later stage on **7DK**.

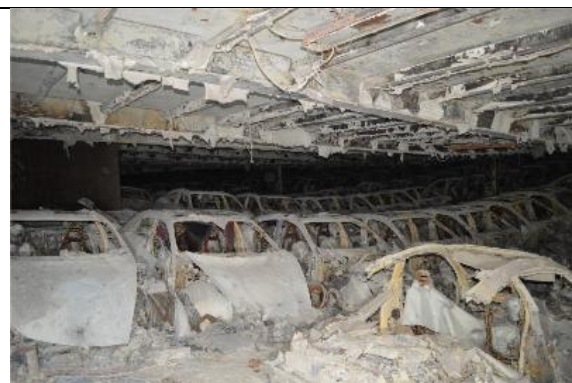
**FIGURE 10A: 9<sup>TH</sup> DECK BURNED  
CARS**  
(Source: Physical inspection O/B - Fire  
Expert Report)

The vehicles on **9, 10, 11, 12DK** were also burned. Although the visible damage to the vehicles on the **12DK** differs from what is visible on the decks below. Probably a lack of oxygen, due to the huge smoke development, affected the burning process on **12DK**

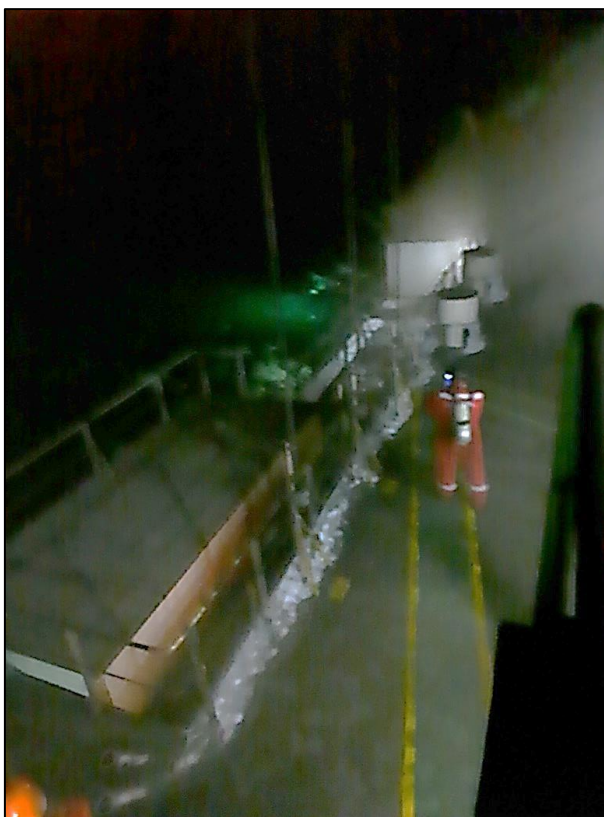
**FIGURE 32: FOAM ACCUMULATED PORT/FISH PLATE**  
(Source: Photograph taken from electrician)

As a direct consequence of the foam system activation, water surfaces formed within the cargo decks. This, coupled with the potential movements of loose cargo/vehicles, caused the vessel to list at a significant angle (10 degrees), on about **01:22hrs LT**. The Master promptly instructed the C/O to correct the list. The C/O, equipped with a BA set, proceeded to the ballast control panel. Simultaneously, the 3rd Engineer Officer, who was in the process of evacuating the E/R, was called back to switch the operation of the Ballast pumps to manual, enabling the C/O to correct the list. The list was successfully corrected by pumping into the healing tank. To further enhance the vessel's stability, which was slightly down by the head at the time, the C/O filled the three after-peak tanks.

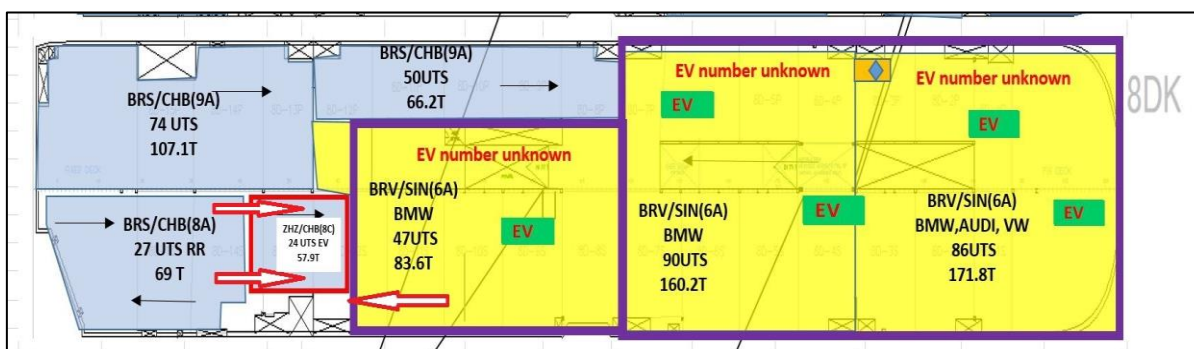
**FIGURE 35: LOCATION OF THE EV CARS IN THE AREA IDENTIFIED AS FIRE POINT OF ORIGIN**

**Regarding its location**, it was confirmed by the duty AB that the fire was initially located **at 8DK hold 4, starboard side, Fr 50-55**, after receiving a fire alarm from a smoke detector in the fire panel, which printout was eventually recovered. **Regarding the fire itself**, it was **firstly observed by the duty AB and subsequently by the 3<sup>rd</sup> Officer coming from an EV** which stowage position coincides with the first activated fire detector location. The evidence indicates the fire source of ignition was an EV within the block of 24 EVs located at stbd side, aft, deck 8 and likely close to the first activated smoke alarm.
