**Report on the findings of:
Current practice and
effectiveness of derailment
containment provisions on high
speed lines**

Issue 1

Zoetermeer, Netherlands
30 September 2004

HSL-Zuid

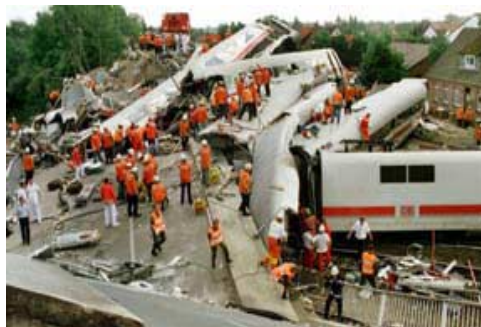
F1. Accident 1 - Eschede, Germany

On Wednesday 3 June 1998, at about 10:59 am local time, northbound ICE (Inter City Express) Train 884 en route from Munich to Hamburg derailed near Eschede, Germany. The ICE Train consisted of two power units (one on each end of the train) and 12 passenger cars. The accident occurred on the Hanover to Hamburg line that was part of the original ICE system. The Hanover to Hamburg section of the ICE system was not newly built but was a renovated line that was upgraded in 1991 from an existing rail line; consequently the line does not meet all Deutsche Bahn (DB) engineering standards for a new high-speed rail line. Mixed traffic, freight and passenger operates on this line. On this section of the rail line, the maximum allowable speed is 200 km/h.

The accident sequence began about 5.6 km before the scene of the general derailment. In this area, the track is tangent and there are no tight curves. The train was operating at 180 km/h, 20 km/h below the authorized speed of 200 km/h for this section of track. At this time, a wheel rim on a two-piece resilient wheel broke on the 3rd axle of the first car behind the lead locomotive. The tread of the wheel separated

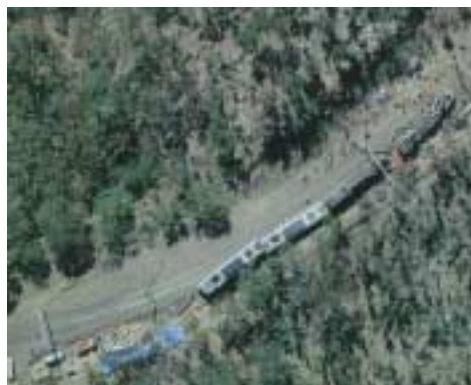
F2. Accident 2 – Waterfall, Australia

At about 7:15 am on Friday 31 January 2003, State Rail Train C311 derailed and overturned on a curve about 2 kilometres south of the Waterfall Station. The train was carrying 47 passengers and 2 crewmembers. Six passengers and the train driver were fatally injured in the accident. Nineteen others were seriously injured and required hospitalisation.

All cars in the train rolled onto their right side and landed on the “up” or westernmost track. As the train slid down the adjacent track, it struck two overhead catenary stanchions and then collided with the rock face of a cutting. The collision with the rock face righted the first two cars. The train came to rest with the front two cars in the upright position and the two rear cars on their right side.

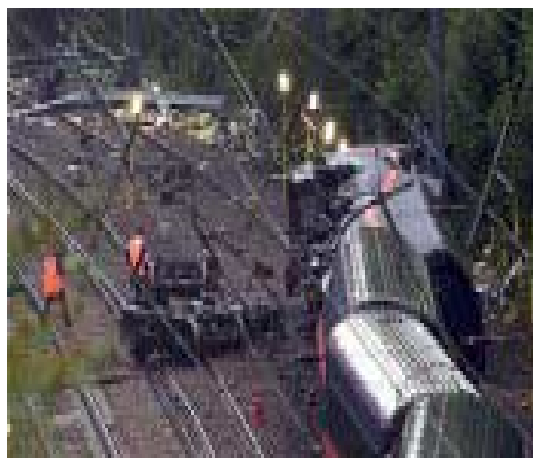
The Hatfield derailment happened because a rail, in which there were multiple cracks and fractures due to rolling contact fatigue (RCF), fragmented when a high-speed train passed over it. The Investigation Board identified, under the heading 'direct causes', a number of interim recommendations intended to prevent this type of catastrophic rail fracture occurring again.

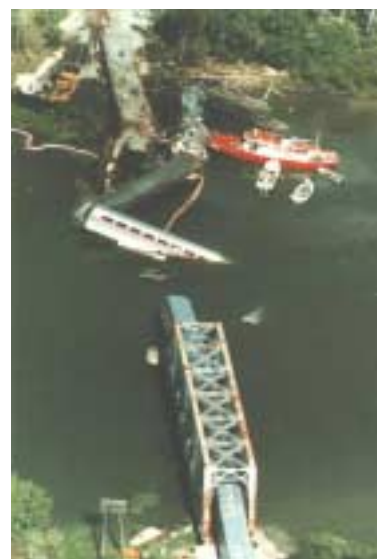
The pilot took a wrong turn in the fog and struck the fixed bridge at Big Bayou Canot displacing the bridge by 38 inches. The lead locomotive of the Sunset Limited struck the displaced bridge at about 116 km/h - flew through the air - and embedded itself 50 feet into the mud.

The National Transportation Safety Board conducted an accident investigation and addressed several safety issues including towboat operator training and evaluation, bridge risk assessment, bridge identification, emergency response and evacuation procedures, and event recorder crashworthiness.

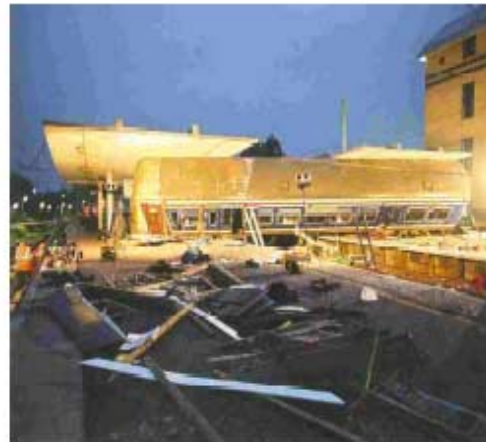
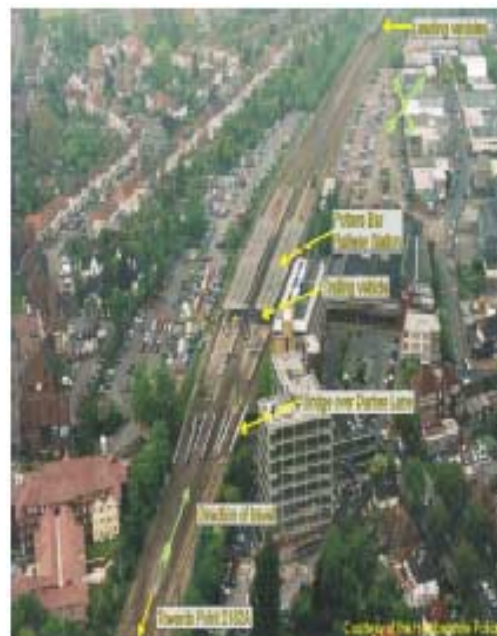
The rear part of the train derailed at points numbered 2182A located about 160 metres south of Potters Bar. The rear bogie of the third coach and both bogies of the fourth coach derailed. The fourth coach slewed sideways so that it was moving broadside to the direction of travel, skidded along the track and detached from the rest of the train. As the fourth coach struck Darkes Lane bridge, the rear bogie was torn off and the coach became airborne. The coach came to rest on its side almost perpendicular to the running lines, straddled across both island platforms and wedged under the station canopy. The coach rolled nearly 360 degrees at least once before coming to a stop. A small waiting shelter on the up platform was partially demolished as the coach skidded towards the canopies. Six passengers travelling in the derailed coach were killed. A number of passengers sustained varying degrees of injuries.

The leading three coaches, with the trailing bogie of the third coach derailed, continued travelling along the Down Fast line passing between the platforms at Potters Bar station. The emergency braking system had been initiated and the coaches came to a halt with the front coach about 400 metres from the northern end of the station platform.

The rear bogie of the fourth coach caused considerable damage to the bridge that passes over the main street (Darkes Lane) of Potters Bar. Debris from the bridge structure and the underside of the rear coach fell on pedestrians and cars below, killing one person.
