ROYAL NETHERLANDS AIR FORCE COMMAND

Air Accident Investigation Report nr: CLSK/Mi-8/2006-001

Aircraft type: Mi-8 MTV-1

(Preliminary) report of the investigation of the accident with the Tryco Mi-8 MTV-1 helicopter, registration YA TAD, on the 26th of July 2006 in East Afghanistan.

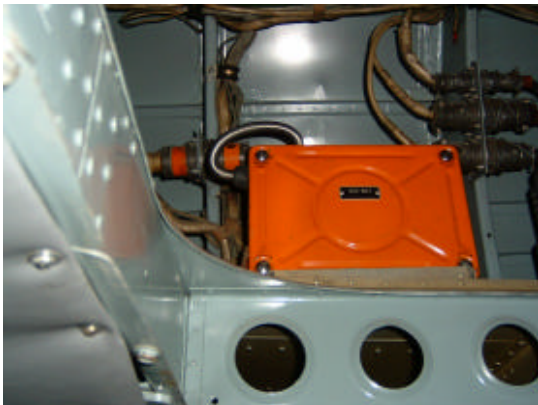
Fig 1. Flight Data Recorder

The helicopter was equipped with a SARPP-12DM type FDR and a MC-61 type CVR, manufactured in Russia and commonly used on this type of helicopter. Both recorders were located in the tailboom section of the helicopter. The FDR was situated on the RH side at the root of the tailboom, the CVR also at the RH side but in the middle of the tailboom (see figures 1-3).

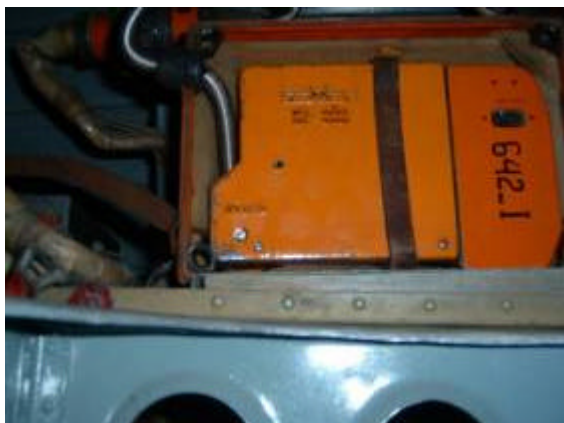
The FDR consists of an actual recording unit and a separate tape cartridge, combined in one overall unit (fig 4), covered with a quick disconnect access panel. The tape cartridge (fig 5) has a recording capacity of 5 to 6 hours. The cartridge installed in the recorder unit therefore needs to be replaced accordingly. To this end, the crew carries some spare tape cartridges in a crate in the rear of the cabin area.

Fig 4. FDR unit with cover removed, consisting of recording unit (left) and tape cartridge (right)

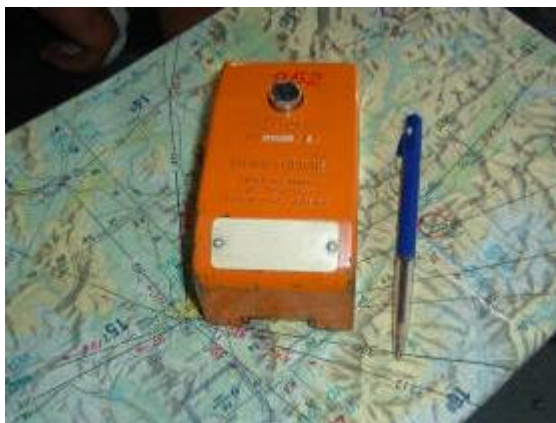
Fig 5. FDR tape cartridge (sample of the two recovered units)

Although it was deemed unlikely that either of the recovered cartridges was actually installed in the recording unit at the time of the accident (it was more likely these were two spare cartridges), both were sent to a facility in Kazakhstan, i.e. Alt Air, for data download and analysis. No data was found on either tape upon analysis by said facility (see report in Annex F). To date, neither the FDR nor the CVR are recovered. They may have been either destroyed completely by the impact and post crash fire or removed from the location by an unauthorized party.

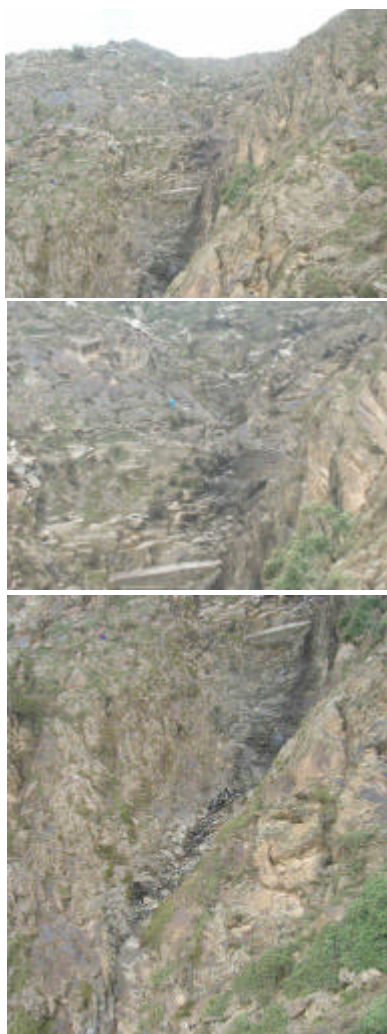
Fig 6. Composition of ravine with impact markings and main location of major parts

1.12 Wreckage and impact information. The helicopter and bodily remains were found in a ravine at the southern base of a ridgeline, situated roughly from west to east (Fig 6). Helicopter parts were scattered throughout a widespread area. In the opinion of the investigation team the helicopter flew into the mountainside horizontally, after which it broke down into several parts and an explosion and fire of the remaining fuel occurred. On the mountainside traces of the post impact explosion and fire were present. Furthermore, some helicopter parts showed intensive fire damage while other parts show no such traces at all (Figs 7-10). As the investigation team did not visit the crash site itself, findings are based on photographs taken by the US recovery team upon their arrival the next day and statements made by said team and Tryco employees that visited the crash site.

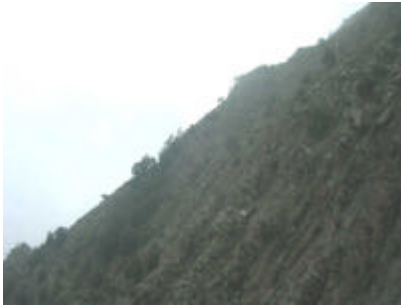
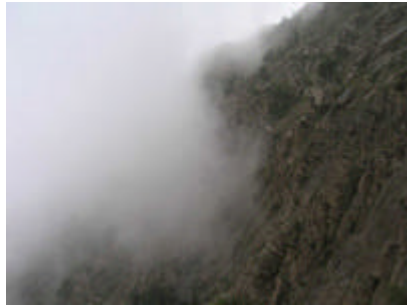
As can be deduced from figures 14 and 15, photographs taken at the accident site during the recovery within a very short timeframe from one another, weather condition in the area can change in a very short

period of time. The photographs also indicate that low clouds could have occurred at one side of the mountain ridge while the other side could have remained relatively clear. An illustration of the poor visibility in case of a cloud layer surrounding the area is shown in the last photograph (Fig 16).

Sub-conclusion. Weather conditions (low clouds, poor visibility, possible turbulence/downdraft) are considered a possible cause or contributing factor in this accident.
