Stability of beam trawlers

RC22C003-1999-rev04

Abstract

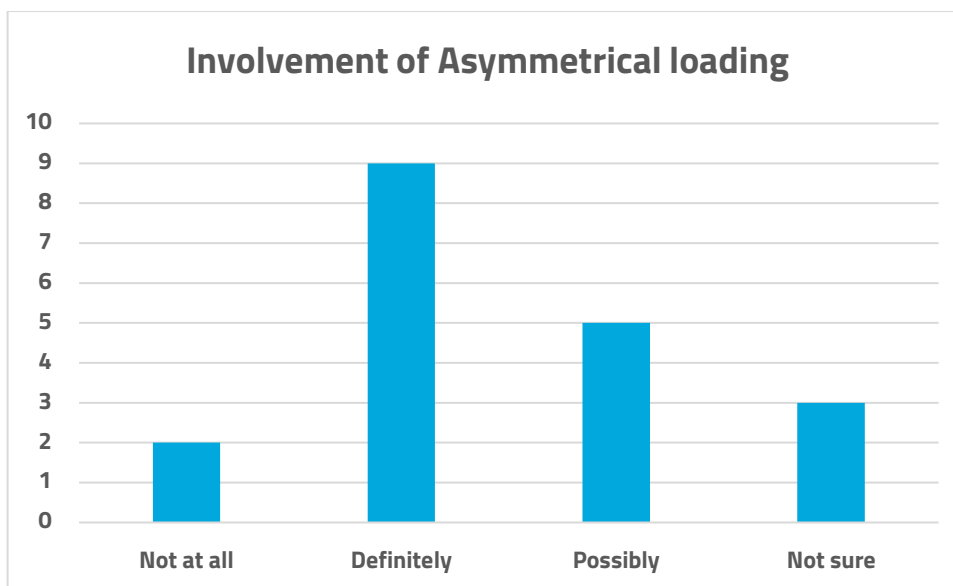
Figure 4: Involvement of asymmetrical loading in the analyzed accidents.

From the accident reports, it has been extracted if the capsizing was caused by asymmetrical loading; either if one of the nets got stuck, a difference in cargo weight in one net compared to the other, or asymmetrical loading on deck. It can be concluded that in 47% of the cases, asymmetrical loading definitely played a key role. And in at least 74% of the cases asymmetrical loading definitely or possibly played a key role. This is illustrated in Figure 4.

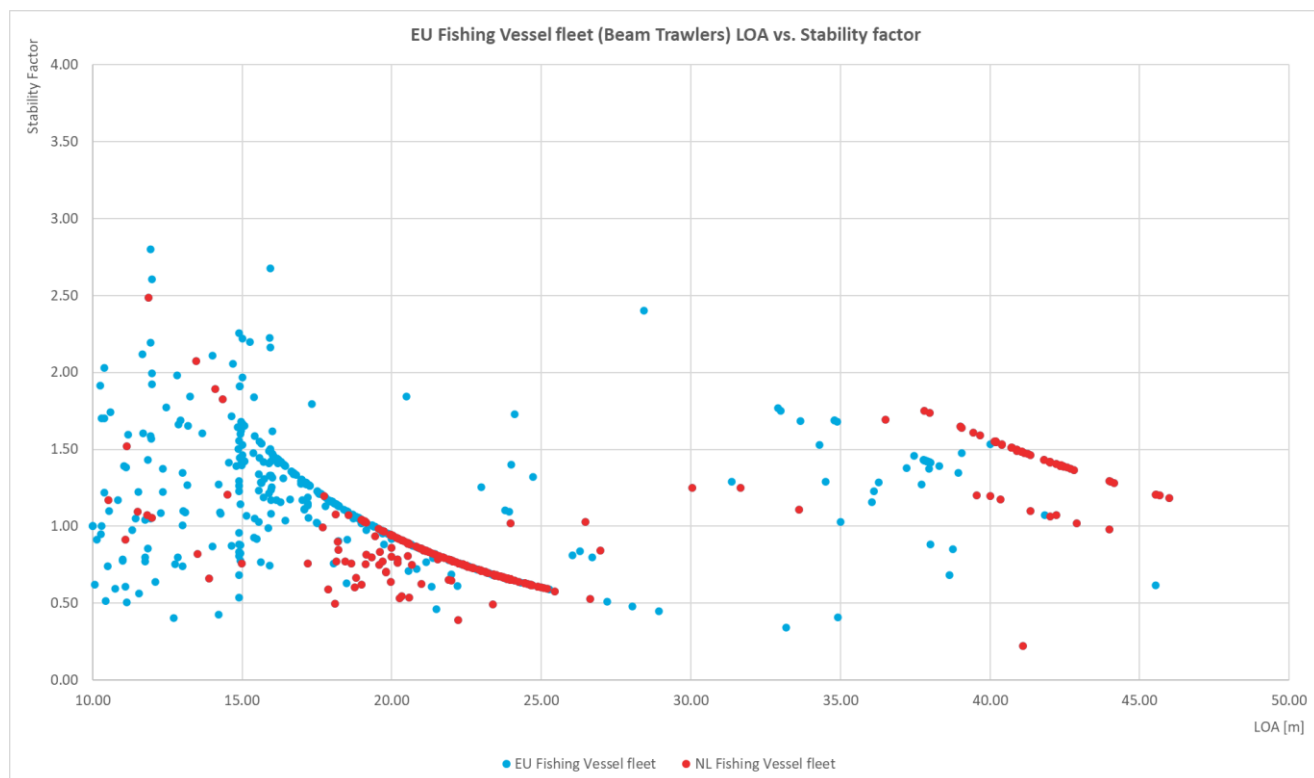
Figure 10: Length over All plotted against stability factor for EU Beam Trawlers

To identify the *stability factor* (introduced in chapter 4.1.2.1), and thereby the possible influence on the minimum applicable stability criteria, the stability factor is calculated for every vessel, and is plotted against LOA. See Figure 10.

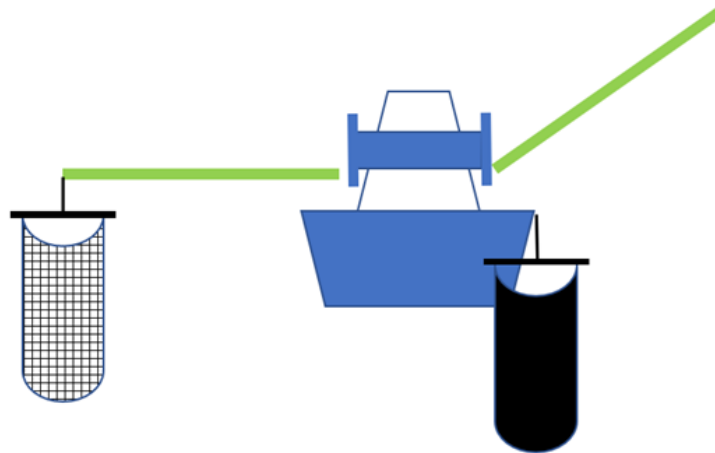
Figure 14: Fishing net lowered to the side of the vessel

When a heavy load is detected in one or both nets, the safety system can be activated. This system lowers the fishing block from the top of the derrick to the side of the vessel, thus drastically reducing the heeling moment acting on the vessel.

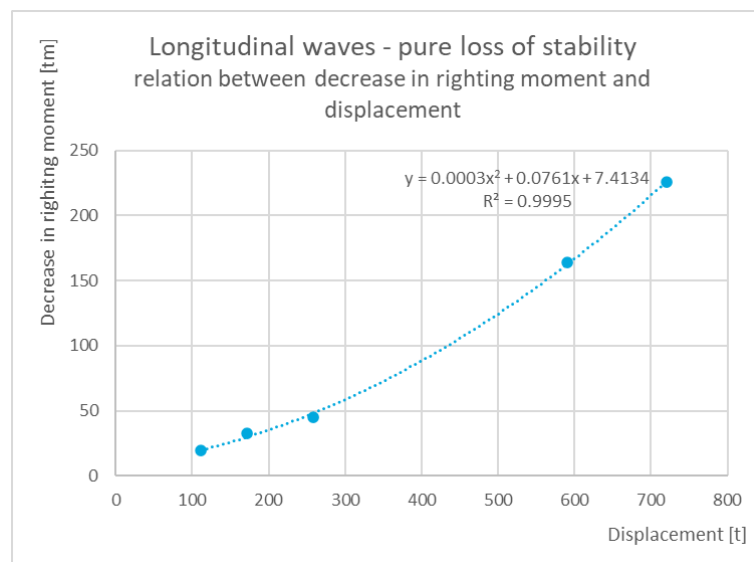
Figure 19: Relation between decrease in righting moment and displacement for a vessel in a longitudinal wave crest.

Based on a number of reference ships, and a calculation of the most unfavorable, but actually occurring, wave steepness in the North Sea, the *decrease in righting moment* was determined by means of PIAS. The result was a decrease of stability between 60% and 90%. A relation was found between displacement and the decrease in righting moment. These results were then translated into a general formula, which was used in the calculation model. The trendline and formula are shown in Figure 19.

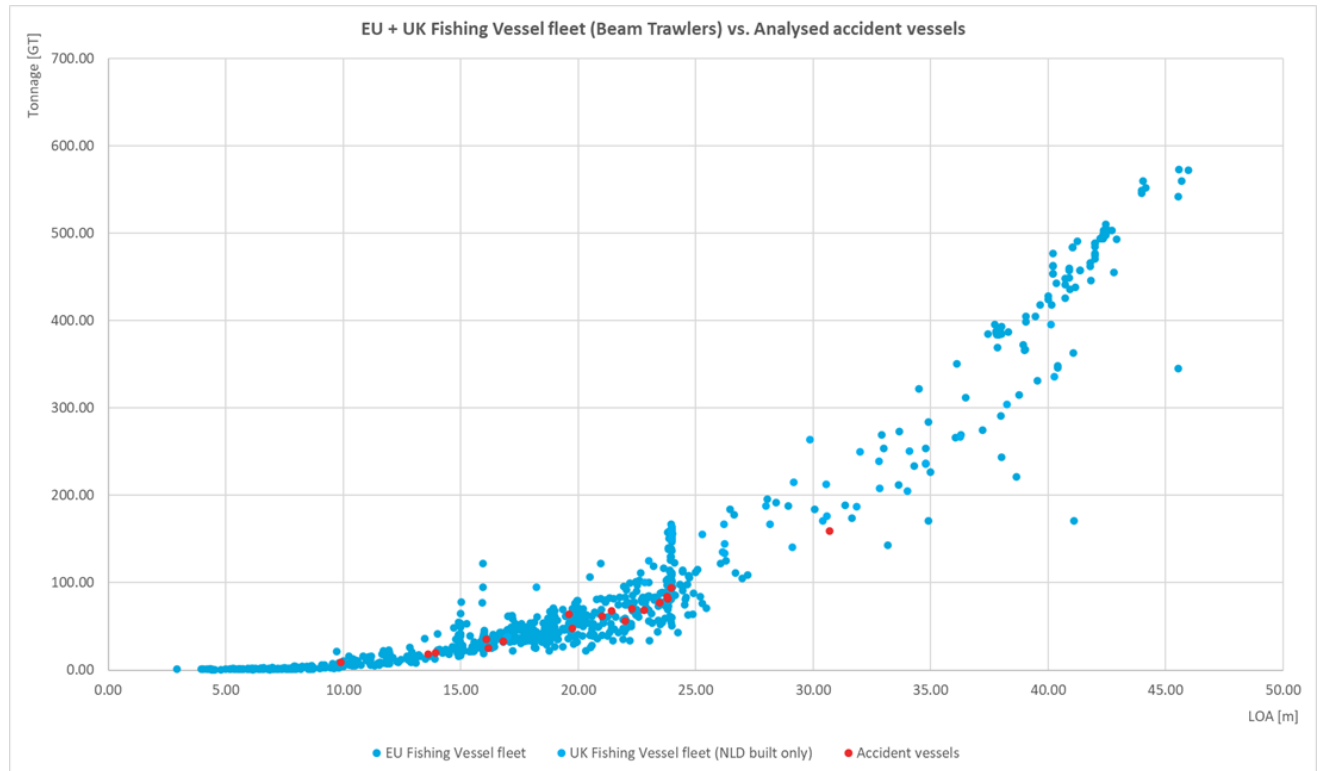
Figure 26: Accident vessels compared to the entire beam trawler fleet

Except for one vessel, all investigated capsizing accidents happened to beam trawlers of 24 m or less, as can be seen in Figure 26. See also chapter 3.

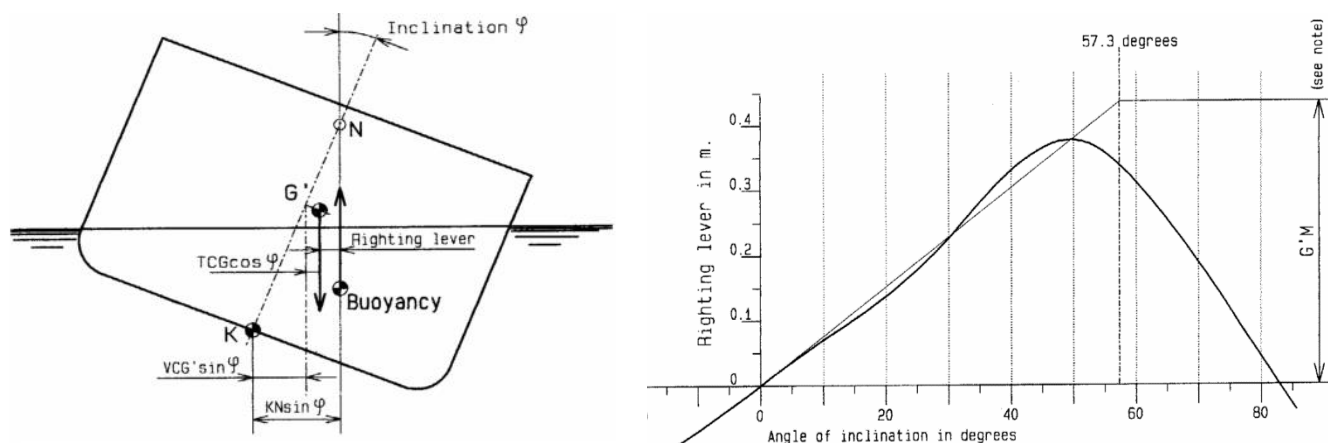
Figure 36: Parameters used in calculation of GZ (righting lever) [left] and GZ-curve [right]

For a better understanding, Figure 36 shows these parameters (left) and the GZ-curve (right)
