**MV “FREMANTLE HIGHWAY”  
IMO 9667344  
FIRE ON BOARD  
Casualty Date: July 25<sup>th</sup> 2023  
Casualty Place: Northsea – The Netherlands EEZ  
VERY SERIOUS MARINE CASUALTY  
REPORT NUMBER: R-016-2024-DIAM**

**SAFETY INVESTIGATION REPORT**

**FIRE ON BOARD M/V FREMANTLE HIGHWAY**

**On July 25<sup>th</sup>, 2023**

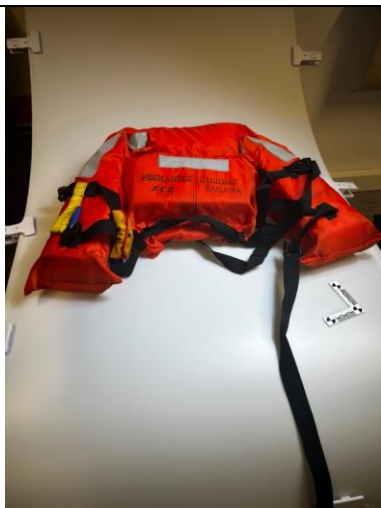
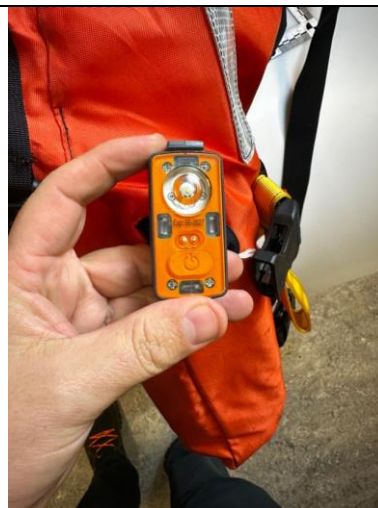
Unfortunately, one of the crew members, an A/B (who was also the first jumper), jumped into the sea/water from the bridge; regardless of the efforts of the medic, he passed away. The official report provided by the local authorities indicates a death during/after the jumping overboard of a 59-year-old man from a great height (30 meters). In the beginning, the lack of obvious injuries makes death by drowning a good possibility, considering it was likely that he swallowed a lot of seawater after jumping and but it was eventually determined that the victim died due to cardiac arrest.

**FIGURE 21A: LIFE JACKET USED  
 BY CREW JUMPED INTO  
 SEA/WATER**

**FIGURE 21B: LIFE JACKET USED  
 BY CREW JUMPED INTO  
 SEA/WATER**

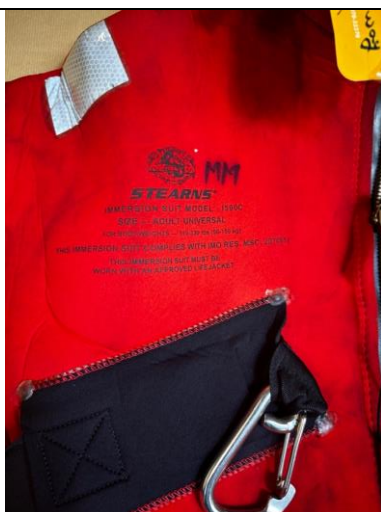
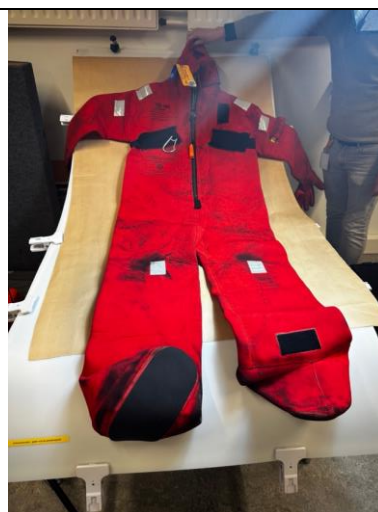
When they were picked up, they were unconscious. It was reported that all of them had a violent landing at sea/water in a flat position, and some had backpacks with them. Therefore, the commander of the rescue boats realised that the “jumping” operation was very risky. Crewmembers were not trained to jump from such a high and, therefore, it was not an appropriate manner to evacuate the vessel; considering that the helicopters were underway, he advised the vessel to instruct crew members to stop jumping into the water/sea.

**FIGURE 22A: IMMERSION SUITS  
 USED FROM CREW JUMPED INTO  
 SEA/WATER**

**FIGURE 22B: IMMERSION SUITS  
 USED FROM CREW JUMPED INTO  
 SEA/WATER**

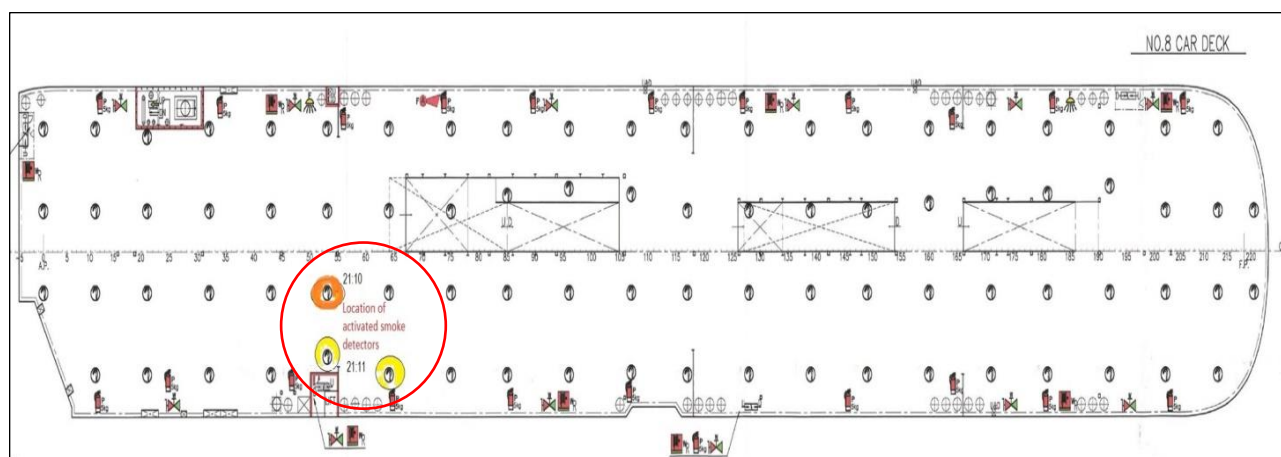
**FIGURE 30: LOCATION OF ACTIVATED SMOKE DETECTORS**  
(Source: Submitted by DSB)

The fire support team was instructed to do the boundary cooling. The C/O instructed the support team to start boundary cooling from aft - meaning the poop deck. C/O clarified that the initial fire alarm was from 8DK, hold 4. The support team brought spare BA bottles and started preparing hoses for boundary cooling on the starboard side of the 12DK. By then, the fire support team could already see from the access to the 12DK that there was smoke. The firefighters were preparing to enter the 12DK, so the hoses were ready on the outside for boundary cooling. There is no other outside area to boundary cool further down, except from aft.

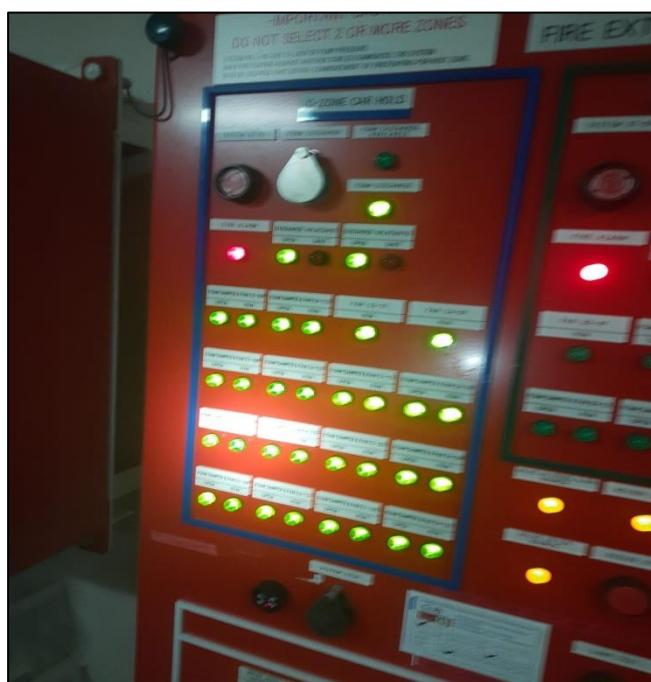
**FIGURE 31: FOAM SYSTEM PANEL**  
(Source: Photograph taken by electrician)

Once the foam system started (on about **23:31hrs LT**), the fire teams reported an increase in smoke, most probably coming out of the vent. At the same time, various explosions could be heard from the cargo decks. One explosion was stronger than the others and caused the 12DK to be deformed.

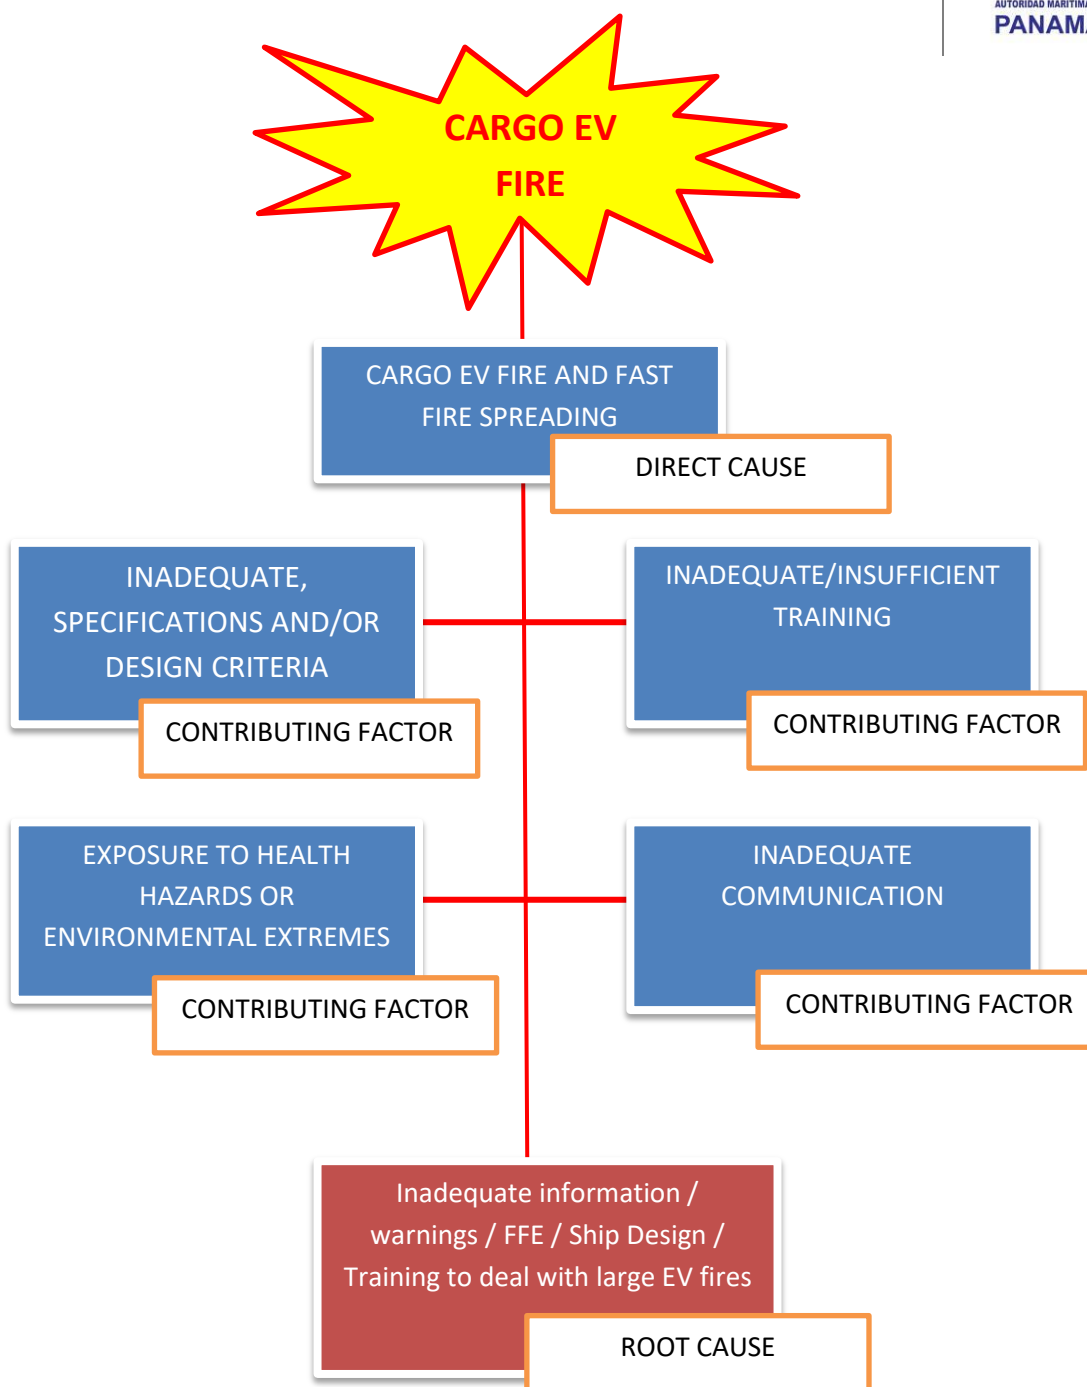
**FIGURE 37: CAUSAL FACTOR DIAGRAM**

## **1. CARGO EV FIRE AND FAST FIRE SPREADING (DIRECT CAUSE)**

#### **4. INADEQUATE COMMUNICATION (CONTRIBUTING FACTOR)**
